**Phase I Environmental Site Assessment  
Proposed Stratford Campus Property (Portions of Parcel Nos. 608141 and 1086107)  
Bunbury Road (Route No. 21)  
Stratford, Queens County, PEI**

**Joose Environmental Project No. JE0495**

**December 15, 2020**

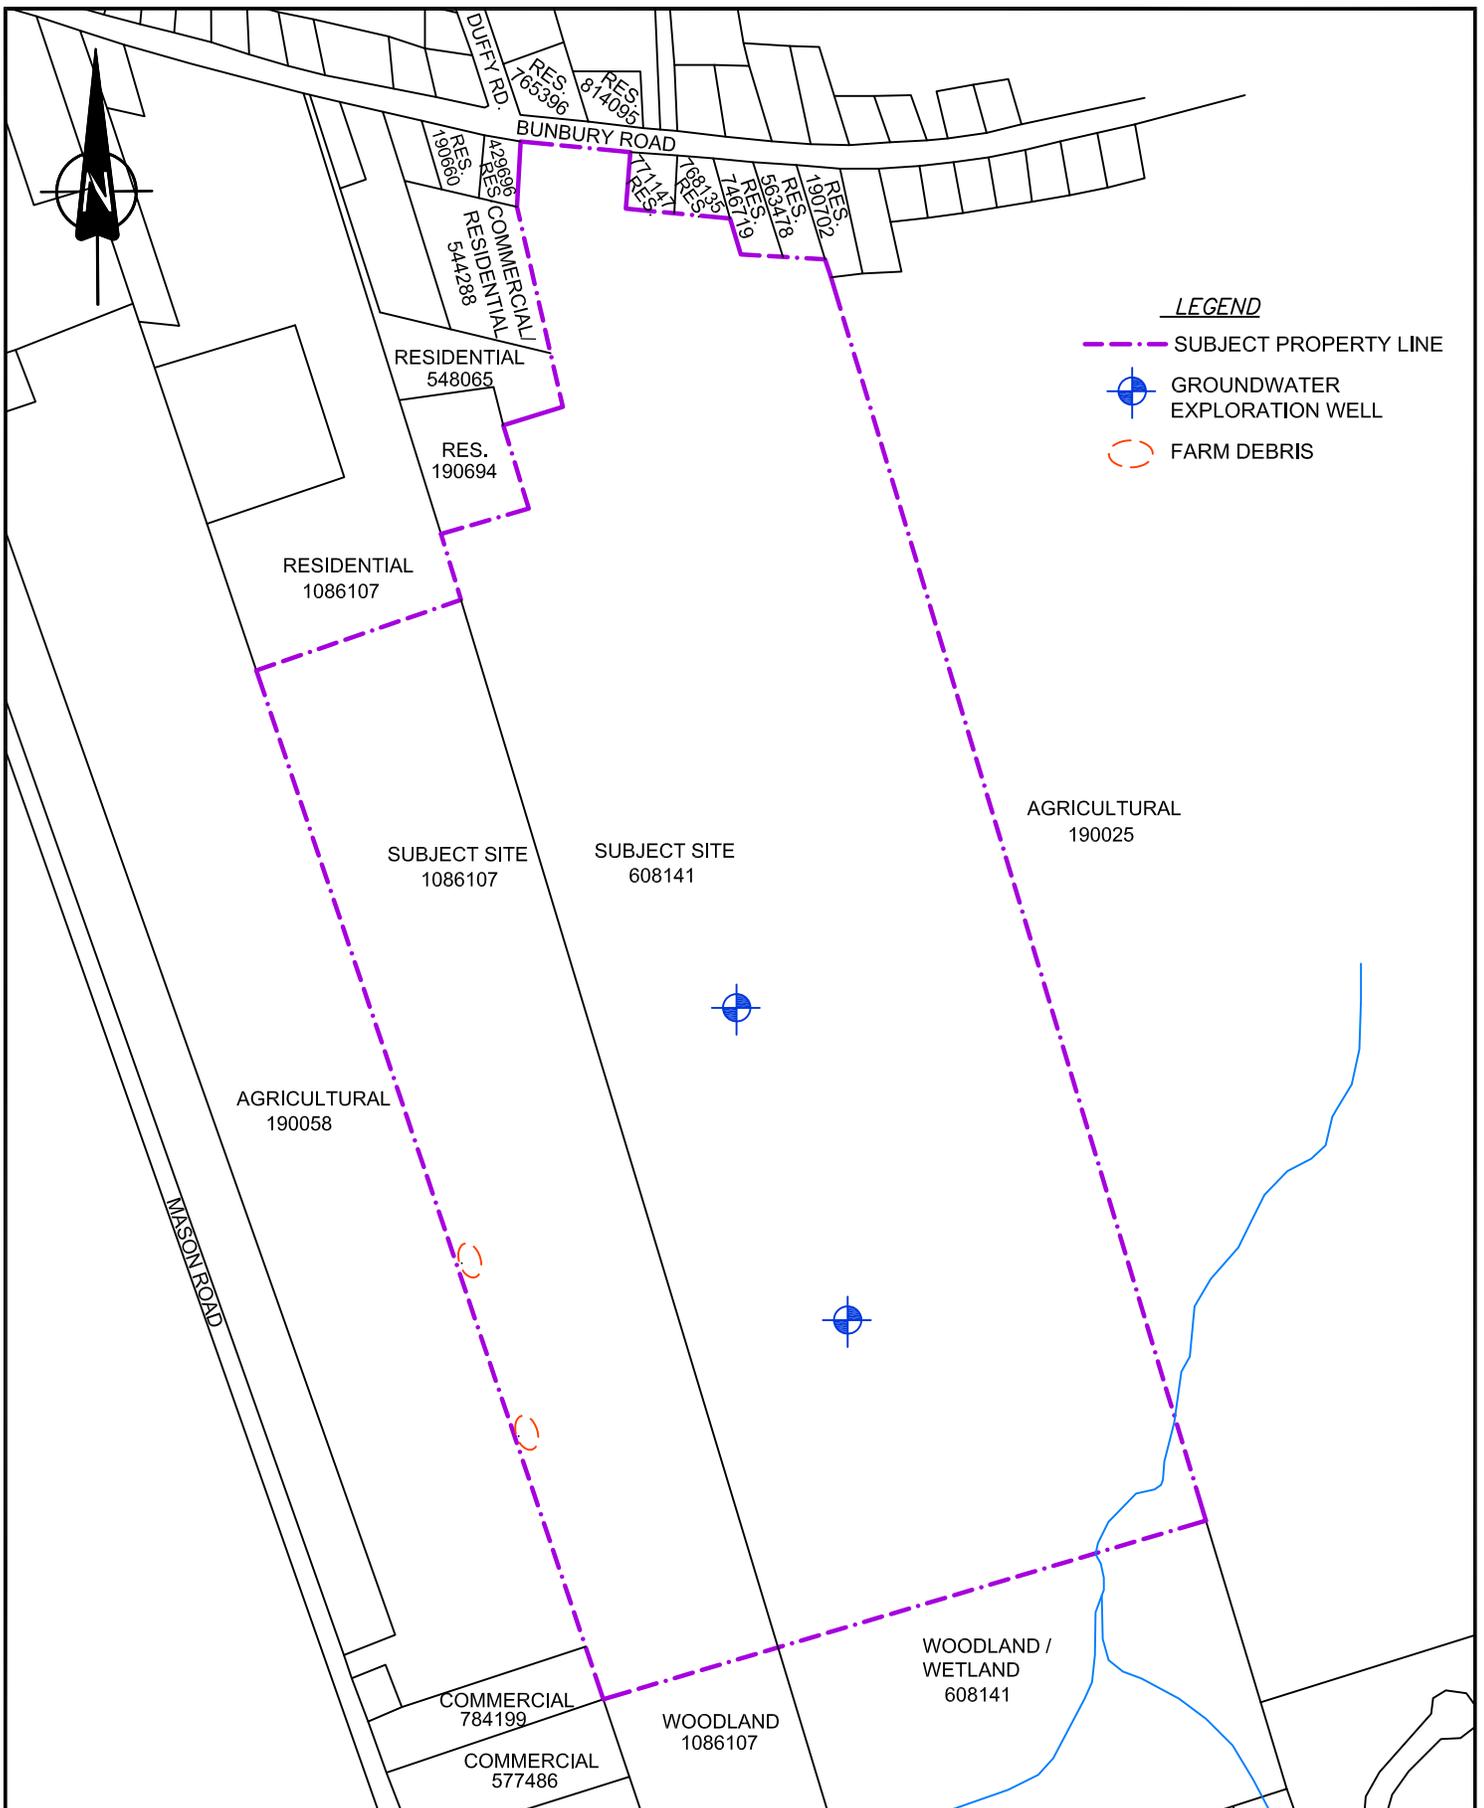
Drawing No. 1 Site Plan - **Appendix A**

As noted previously, some farming-related debris, including derelict farming equipment, 45-gallon drums, vehicle tires/wheels, scrap timber/steel, and a vehicle's gasoline tank were observed at specific locations within the treed west boundary of the subject site. The farming related debris is shown on Drawing No. 1, **Appendix A** at the following GPS coordinates:

Two drilled groundwater exploration wells were observed on the subject site as shown on Drawing No. 1, **Appendix A** and having the following GPS locations:

It is recommended, in accordance with good environmental practice, the various farming-related debris (i.e., empty steel drums, steel roofing, farm equipment, empty steel vehicle fuel tanks, wood, etc.) observed be removed and properly disposed of. No soil staining/stressed vegetation or hydrocarbon odour was identified during the site visit. In the event surface impacts are identified during the removal of the debris, the impacted soil should be removed and disposed of according to Provincial Regulations with close-out samples collected by a qualified environmental consultant.

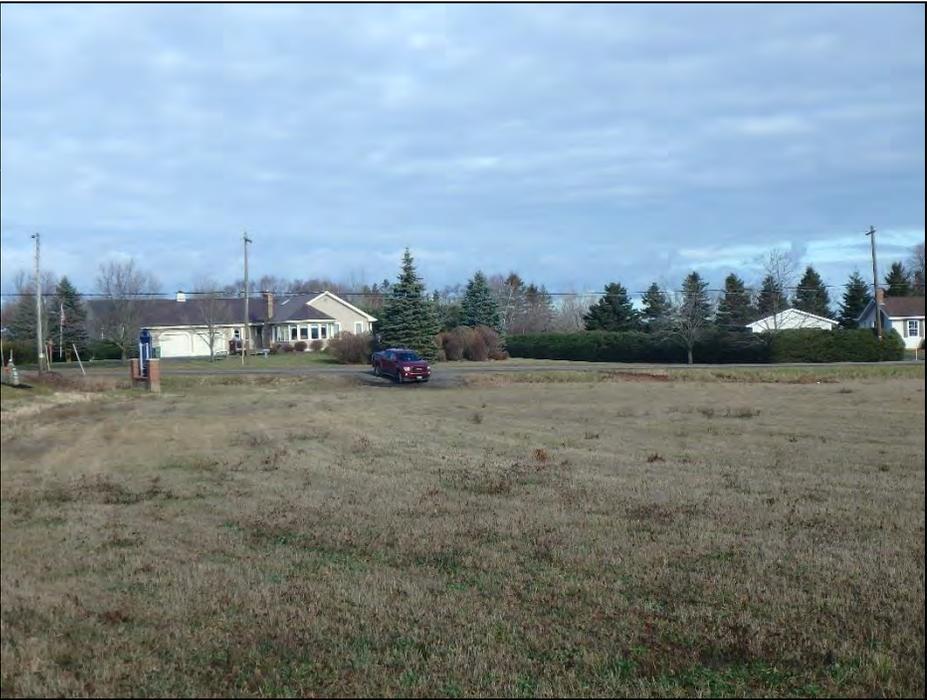
Photograph No. 1

Date Taken: December 3, 2020	
Description:  View of the northernmost portion of the subject site, bordering on the Bunbury Road.	
Looking Towards: Northeast

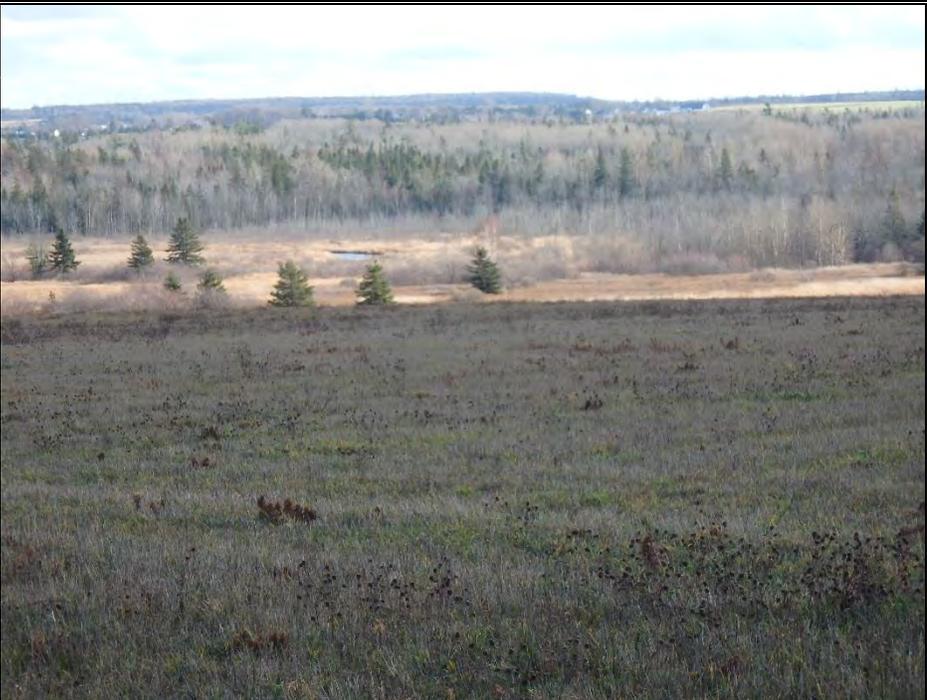
Photograph No. 2

Date Taken: December 3, 2020	
Description:  View across the central portion of the subject site showing the stream on the adjoining property to the east (PID 190025) in the background.	
Looking Towards: Southeast

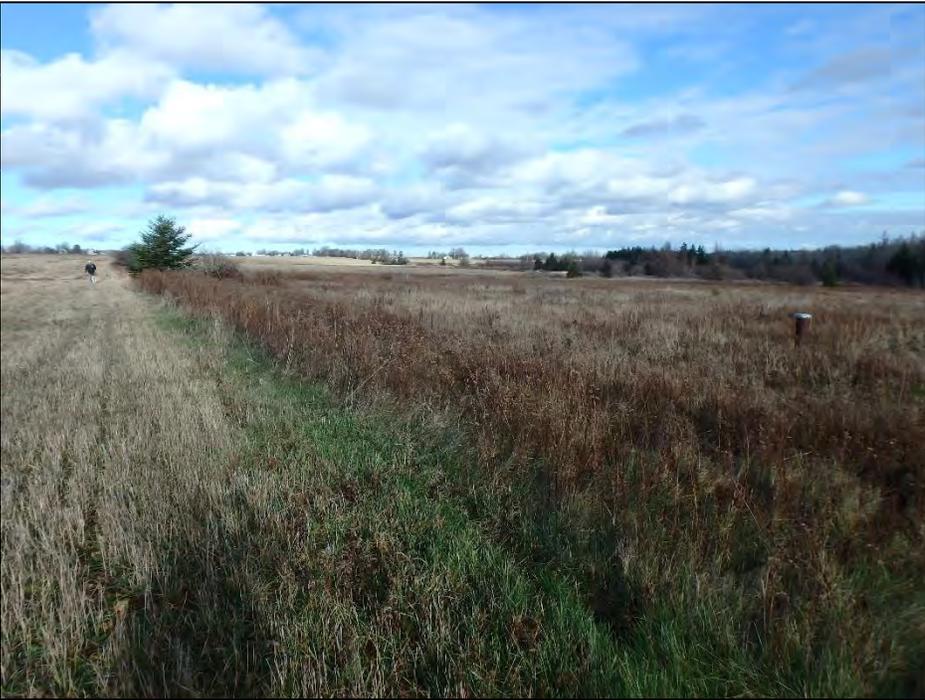
Photograph No. 3

Date Taken: December 3, 2020	
Description:  View of the south-central portion of the subject site showing a drilled well to the right.	
Looking Towards: Northeast

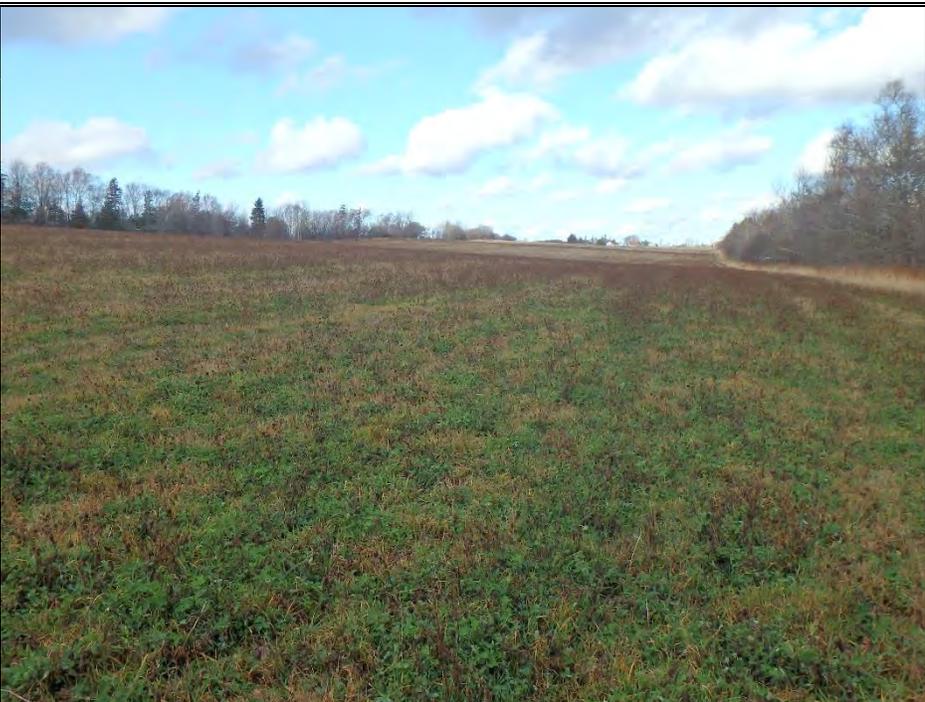
Photograph No. 4

Date Taken: December 3, 2020	
Description:  View of the south portion of the subject site.	
Looking Towards: North

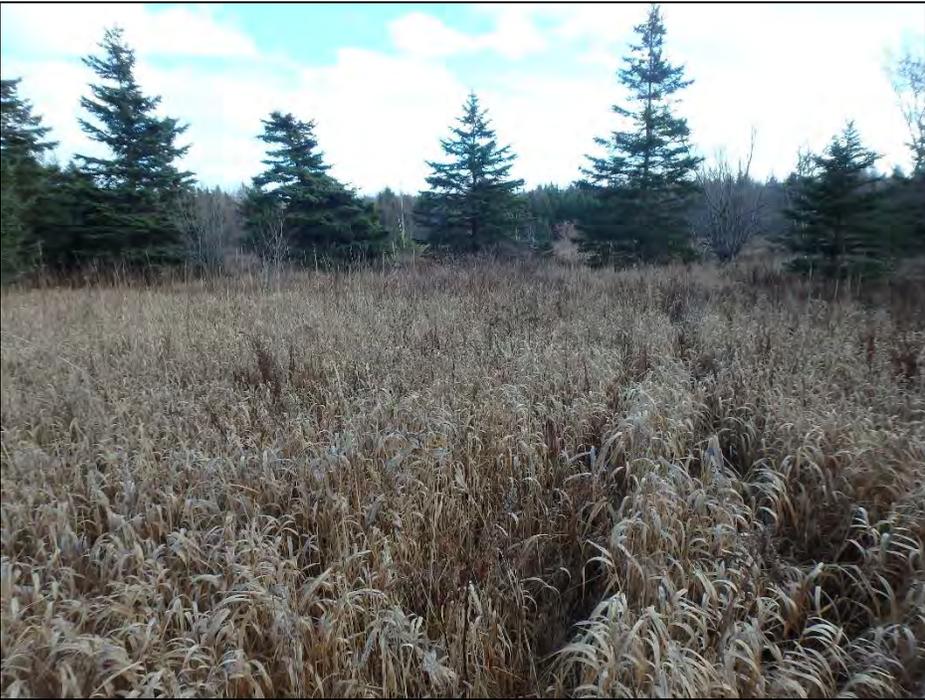
Photograph No. 5

No stained surficial materials or stressed vegetation were observed to be on the subject site. No watercourses, pits and lagoons were identified on the subject property and no standing water was observed with the exception of an unnamed stream and associated potential wetland located on the southeast portion of the subject site (i.e., Parcel No. 608141). In the event future development is planned in this area of the property, a wetland delineation should be undertaken to ensure conformance to Provincial buffer zone regulations.

Date Taken: December 3, 2020	
Description:  View of a wetland located within the southeast portion of the subject site.	
Looking Towards: East

In addition, an unnamed stream and associated potential wetland was identified on the southeast portion of the subject site (i.e., Parcel No. 608141) during the completion of the Phase I ESA. In the event future development is planned in this area of the property, a wetland delineation should be undertaken to ensure conformance to Provincial buffer zone regulations.

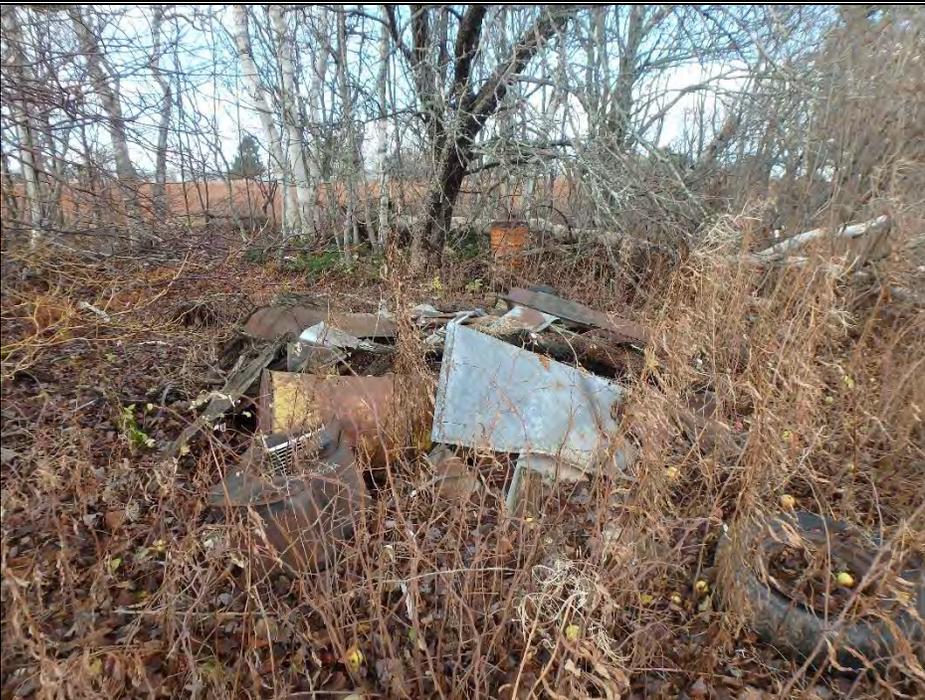
Photograph No. 6

No chemical or fuel storage containers were observed or reported at the subject property with the exception of some abandoned 45-gallon drums located along the treed west boundary of the subject site of the subject site as noted previously.

Date Taken: December 3, 2020	
Description:  View of various debris, including 45-gallon drums located on the western property boundary of the subject site.	
Looking Towards: Northwest

It is recommended however, in accordance with good environmental practice, the various farming-related debris (i.e., empty steel drums, steel roofing, farm equipment, empty steel vehicle fuel tanks, wood, etc.) observed at specific locations along the treed west boundary of the subject site (i.e., Parcel No. 1086107 - GPS coordinates provided in body of text) be removed and properly disposed of. No soil staining/stressed vegetation or hydrocarbon odour was identified during the site visit. In the event surface impacts are identified during the removal of the debris, the impacted soil should be removed and disposed of according to Provincial Regulations with close-out samples collected by a qualified environmental consultant.

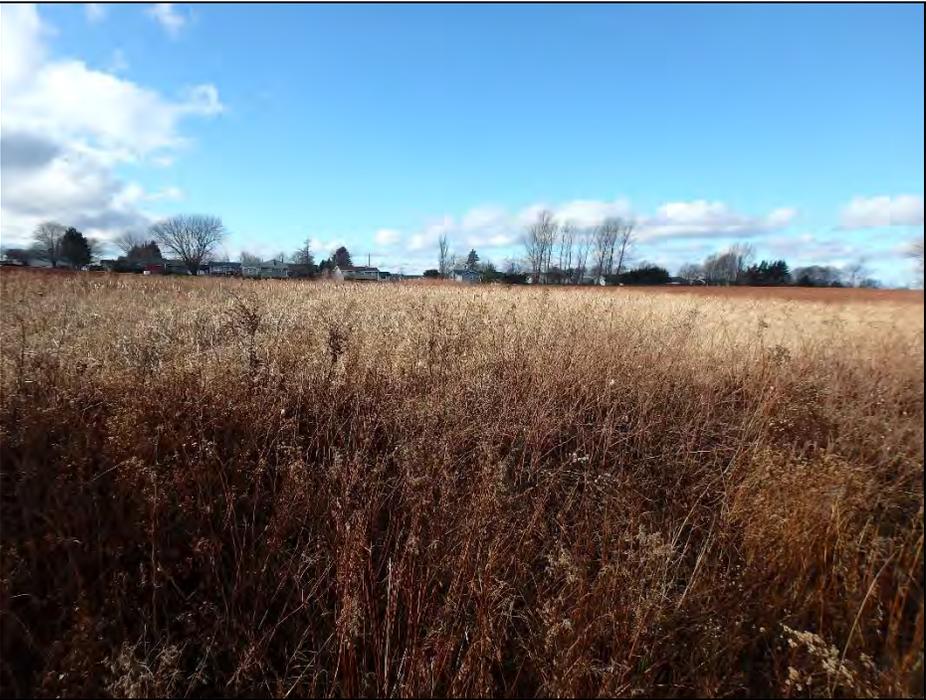
Photograph No. 7

Date Taken: December 3, 2020	
Description:  View of a wetland/pond located on the adjoining property to the west (PID 190058).	
Looking Towards: Northwest

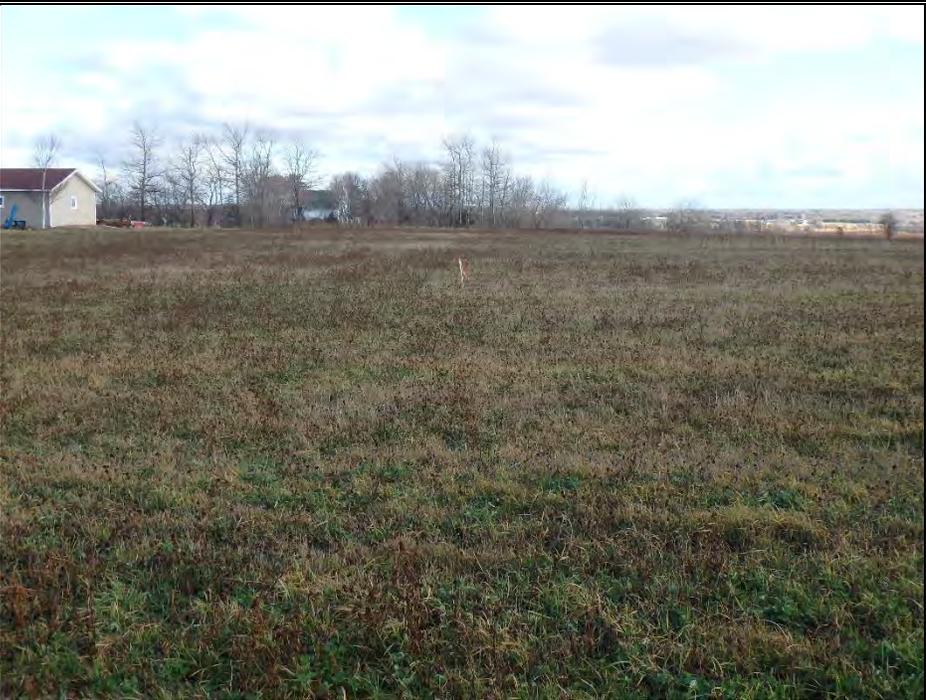
Photograph No. 8

Date Taken: December 3, 2020	
Description:  View of the new property boundary along the north site of PID 1086107.	
Looking Towards: Northeast

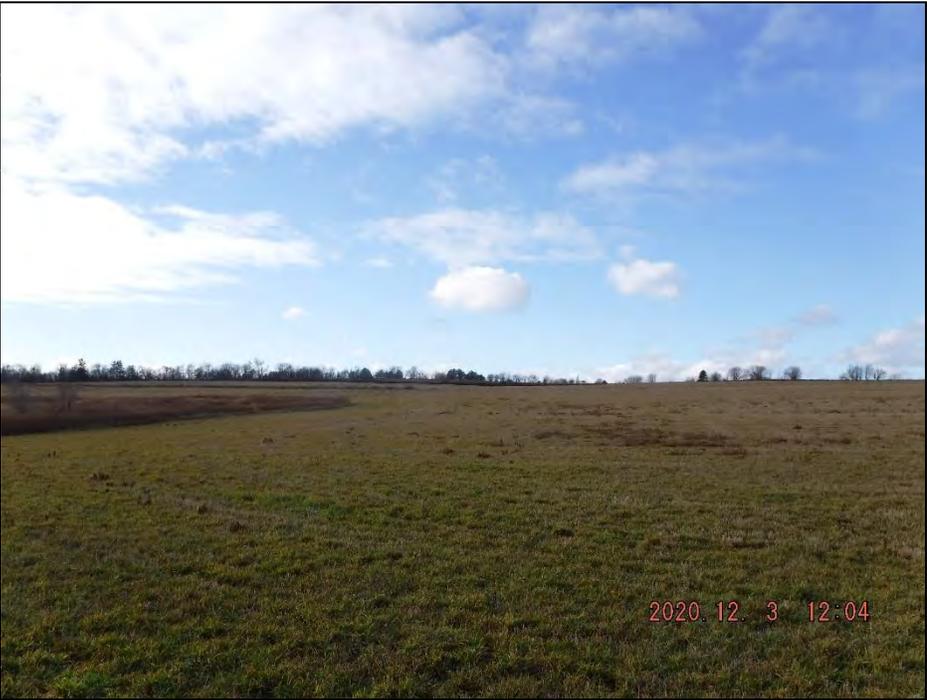
Photograph No. 9

Date Taken: December 3, 2020	
Description:  View of the central portion of the subject site.	
Looking Towards: Southwest

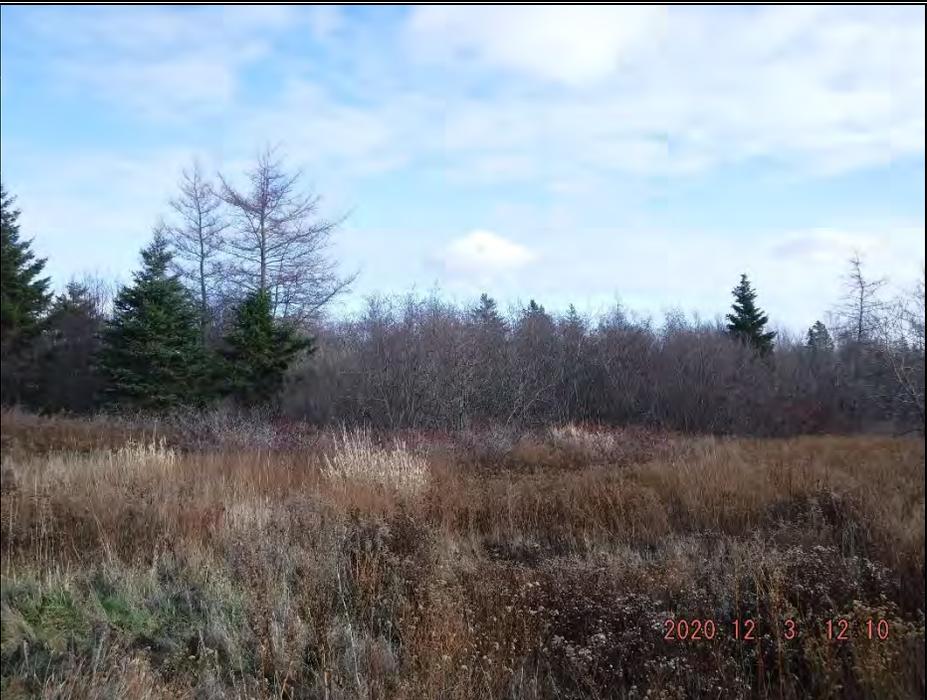
Photograph No. 10

Date Taken: December 3, 2020	
Description:  View of the undeveloped southeast portion of the subject site.	
Looking Towards: Southeast
